# Chemical Process Safety

Learning from  
Case Histories

Third Edition

ROY E. SANDERS

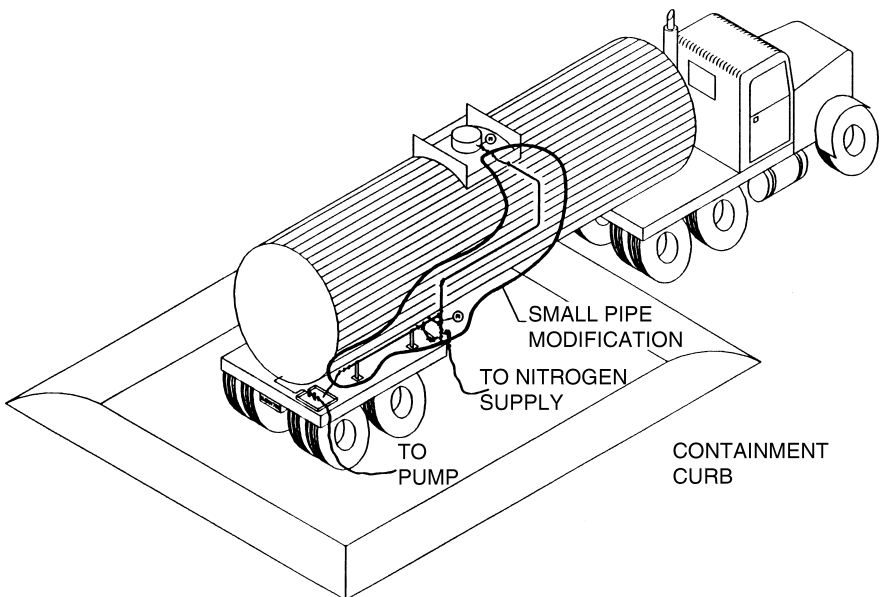
FIGURE 2-3 Tractor and tank truck ready to unload. Courtesy of Manuel David.

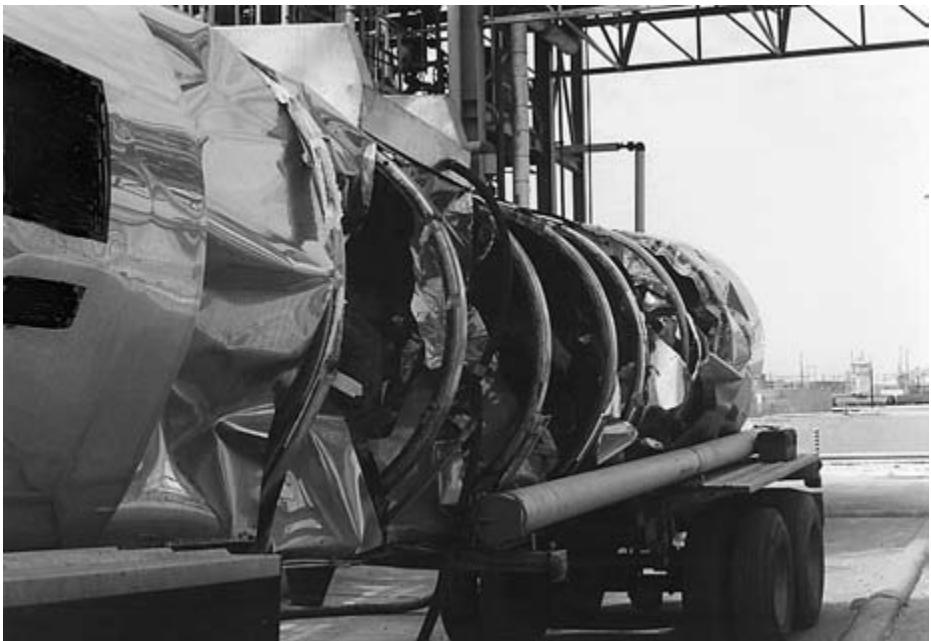
FIGURE 2-5 Close-up of tank failure and exposed ribs.

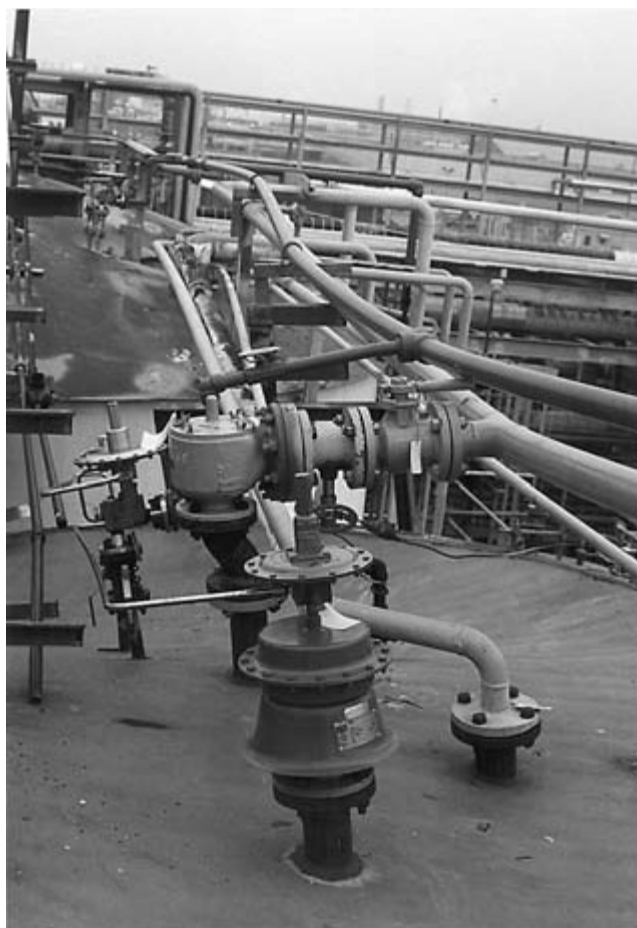
FIGURE 2-15 New but visually confusing piping system—after the incident.

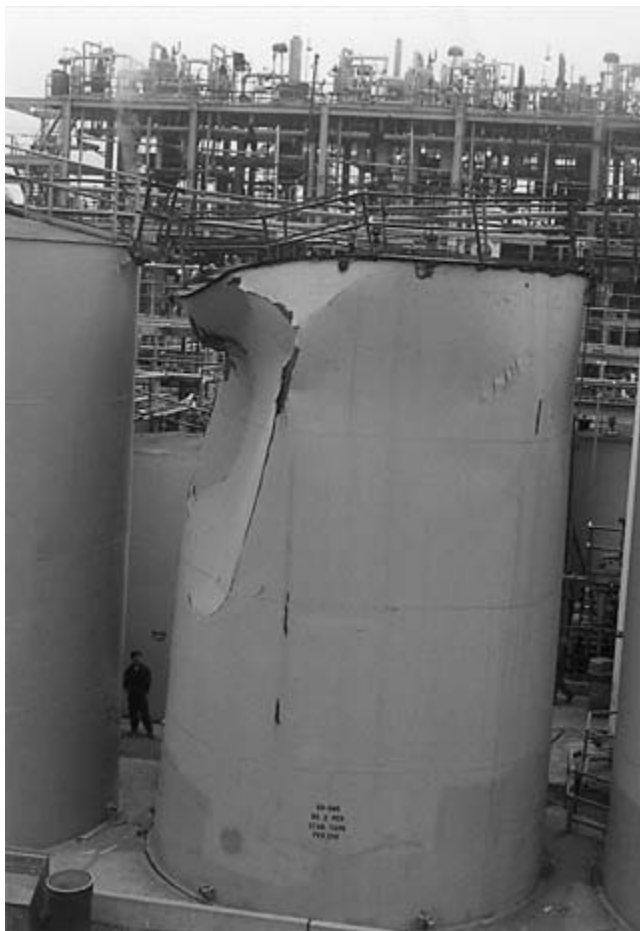
FIGURE 2-16 Crushed tank in the tank farm.

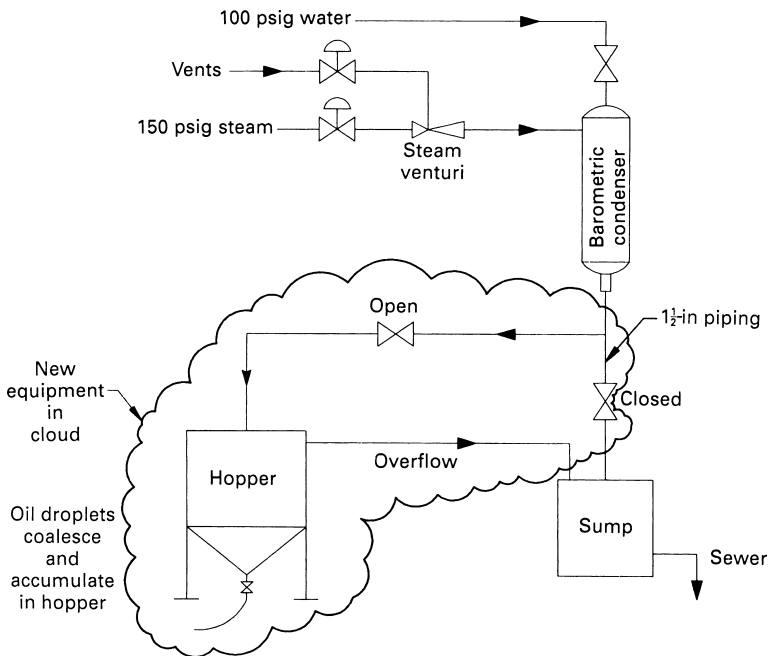
FIGURE 2–17 Modifications on water piping to reduce pollution potentials.  
Courtesy of Jack M. Jarnagin.

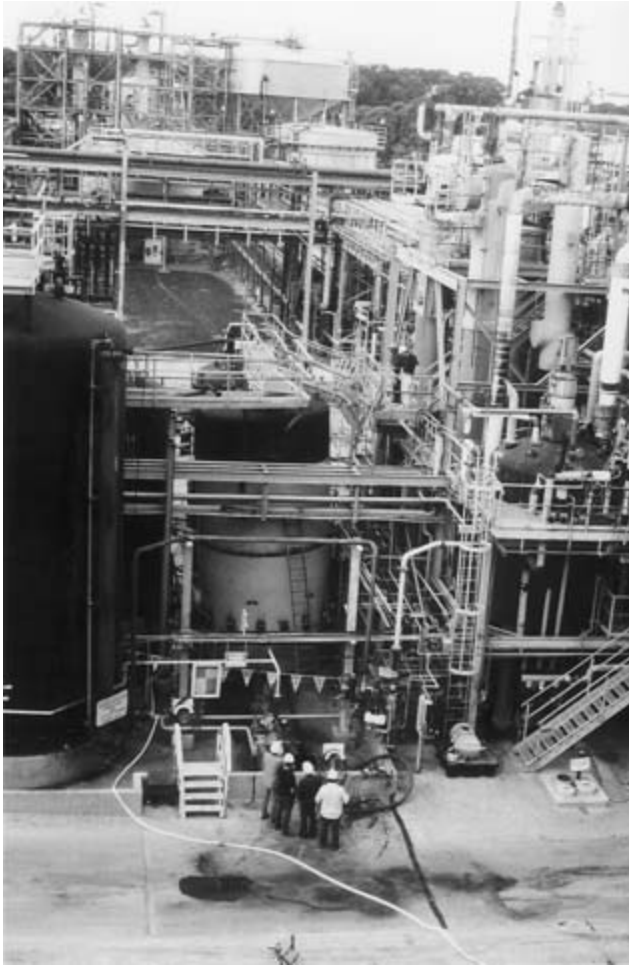
FIGURE 3-1 An API 620 tank is damaged during a hydrotest.

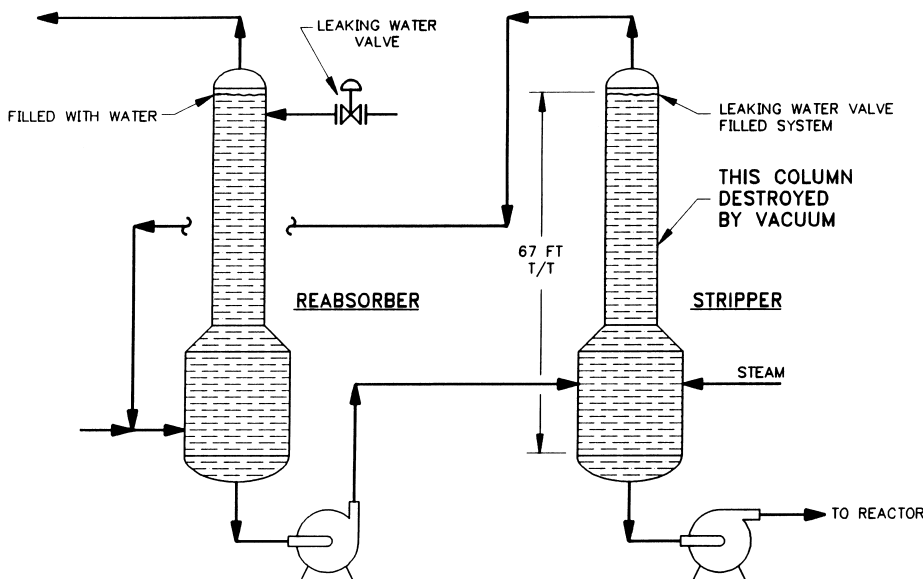
FIGURE 3-6 The design of the reabsorber/stripper system. Courtesy of Guido DeJesus and Warren Schlindler.

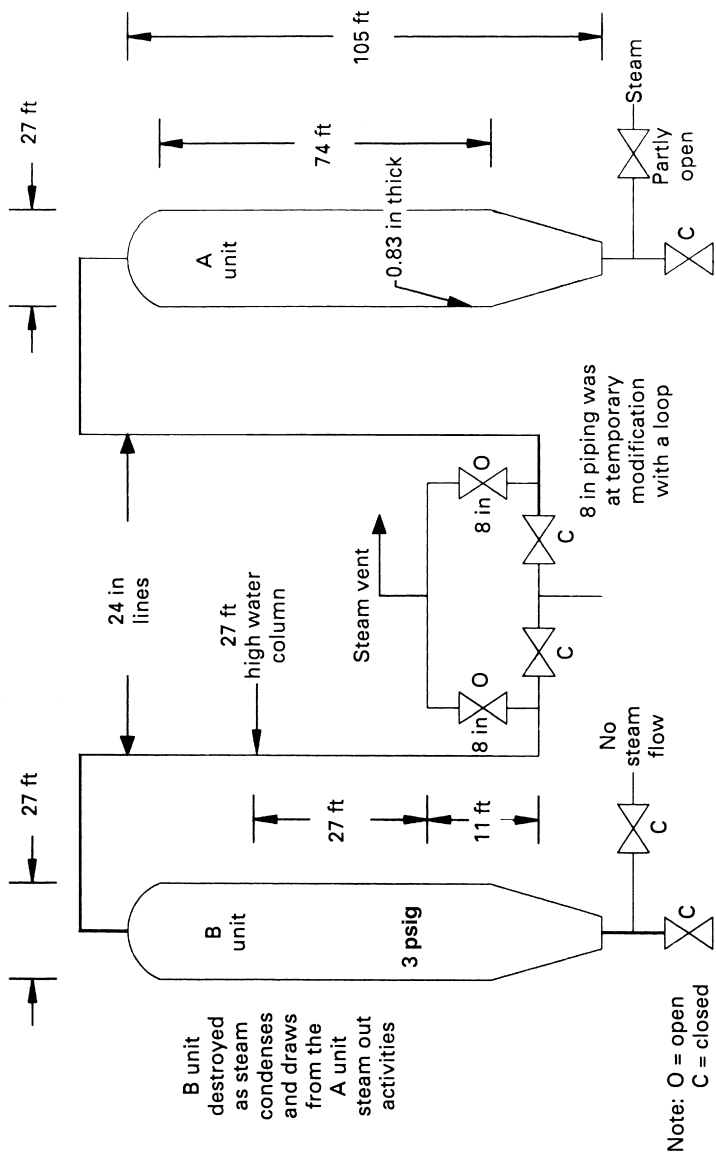
FIGURE 3-10 Conditions at the time of the failure of the coker drum.

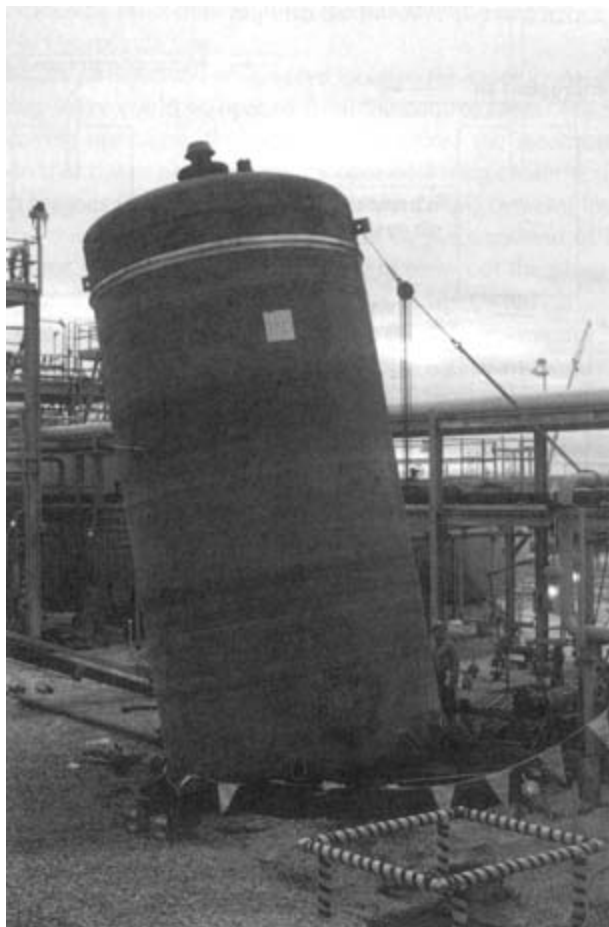
FIGURE 5-12 A large acid tank fails due to blocked vent and a blocked overflow line.

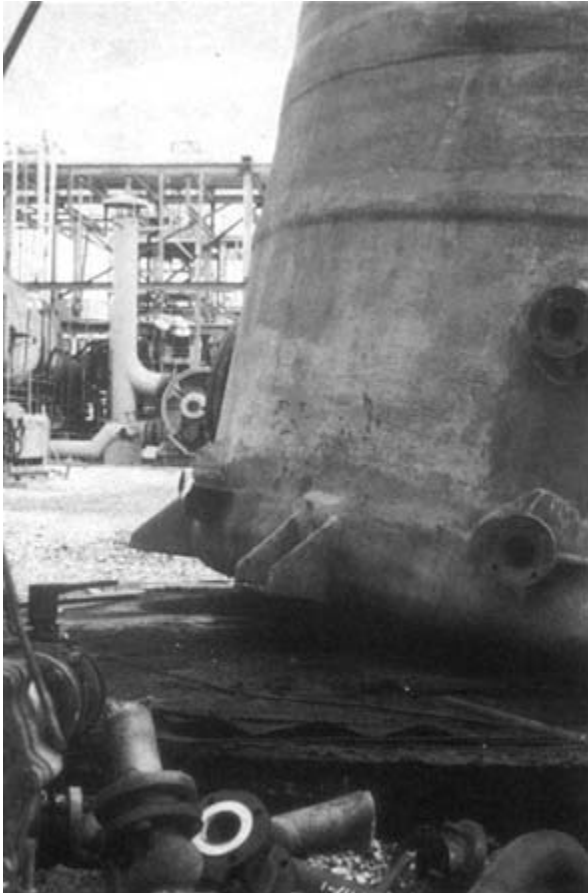
FIGURE 5-14 A close-up of the failed tank base.

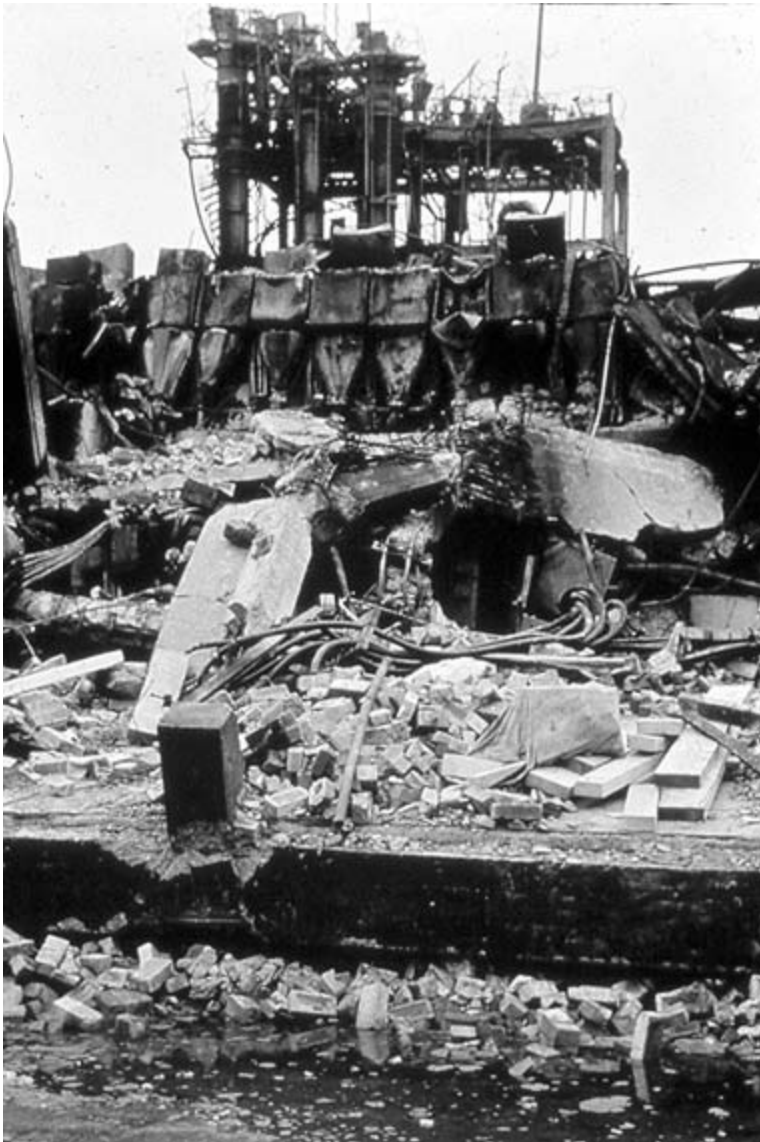
FIGURE 5-17 The rubble of the crushed control room at Flixborough. Courtesy of Trevor A. Kletz.

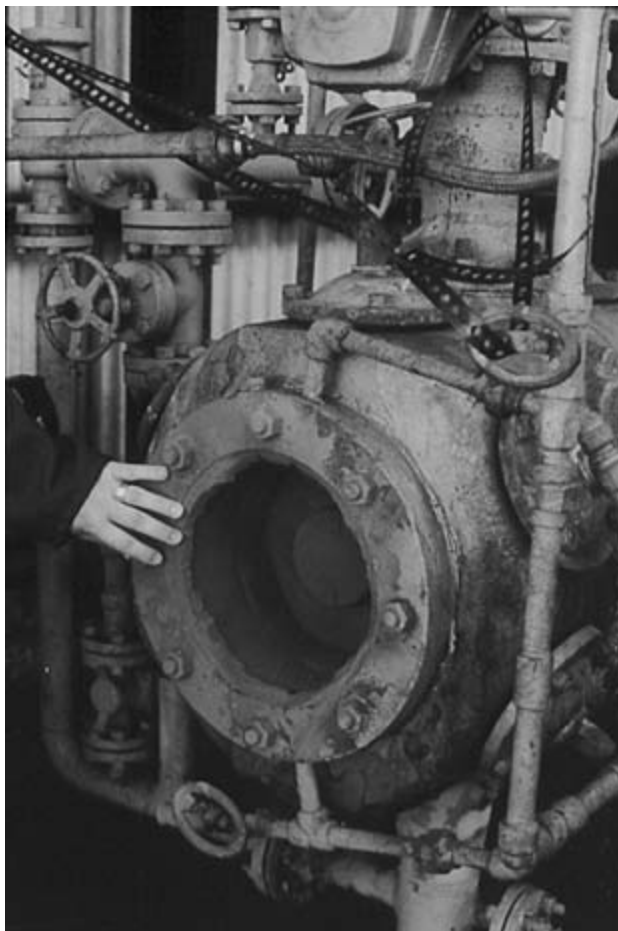
FIGURE 7-2 Close-up of ruptured water jacket on compressor.

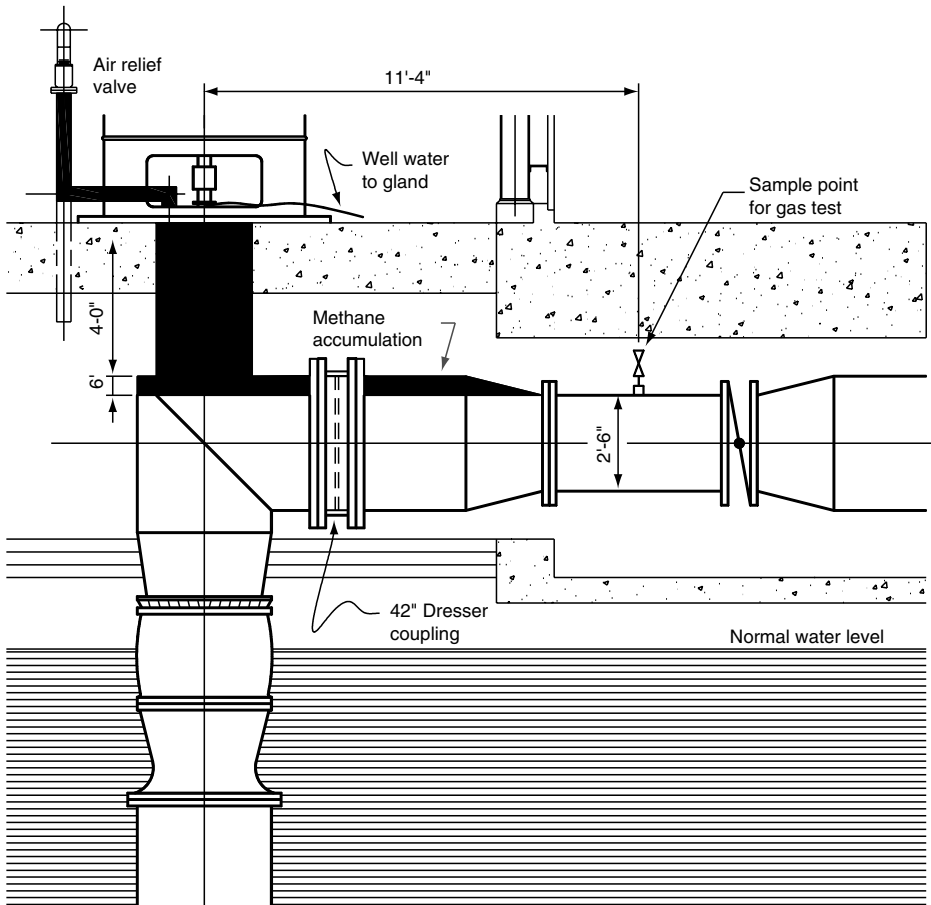
FIGURE 7-11 Sketch of how methane gas accumulated in the river water piping.

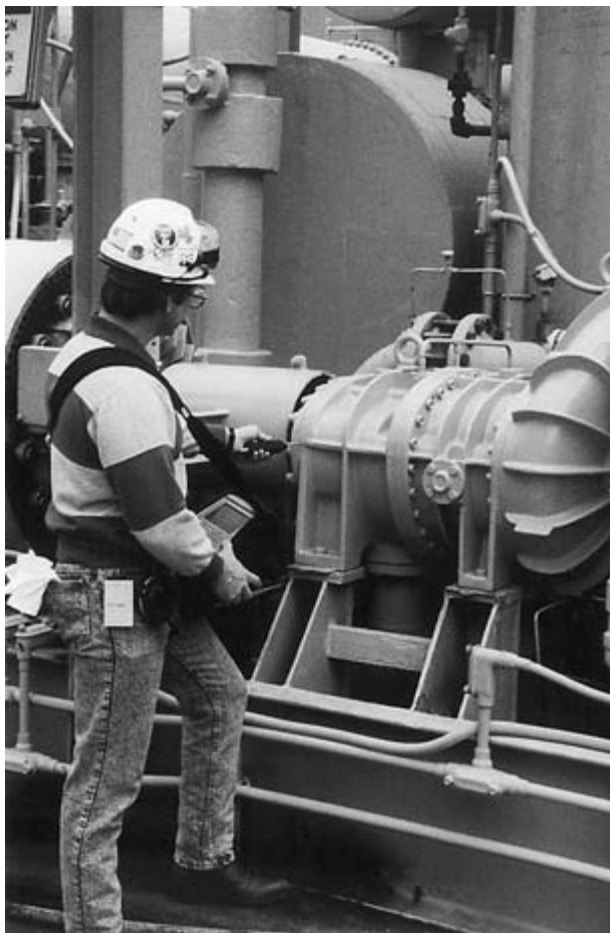
FIGURE 10-3 A vibration technician taking readings on a refrigeration compressor.
